Massachusetts Department of Environmental Protection
Bureau of Resource Protection – Watershed Permitting Program
**Sanitary Sewer Overflow (SSO)/Bypass
Notification Form**

HULL, MA WPCF
Reporting Sewer Authority

S.S.O. DATE: APRIL 14, 2016

SUMMARY OF ADDITIONAL INFORMATION RELATED TO S.S.O. TO INCLUDE CMOM/AOC REQUIRED INFO

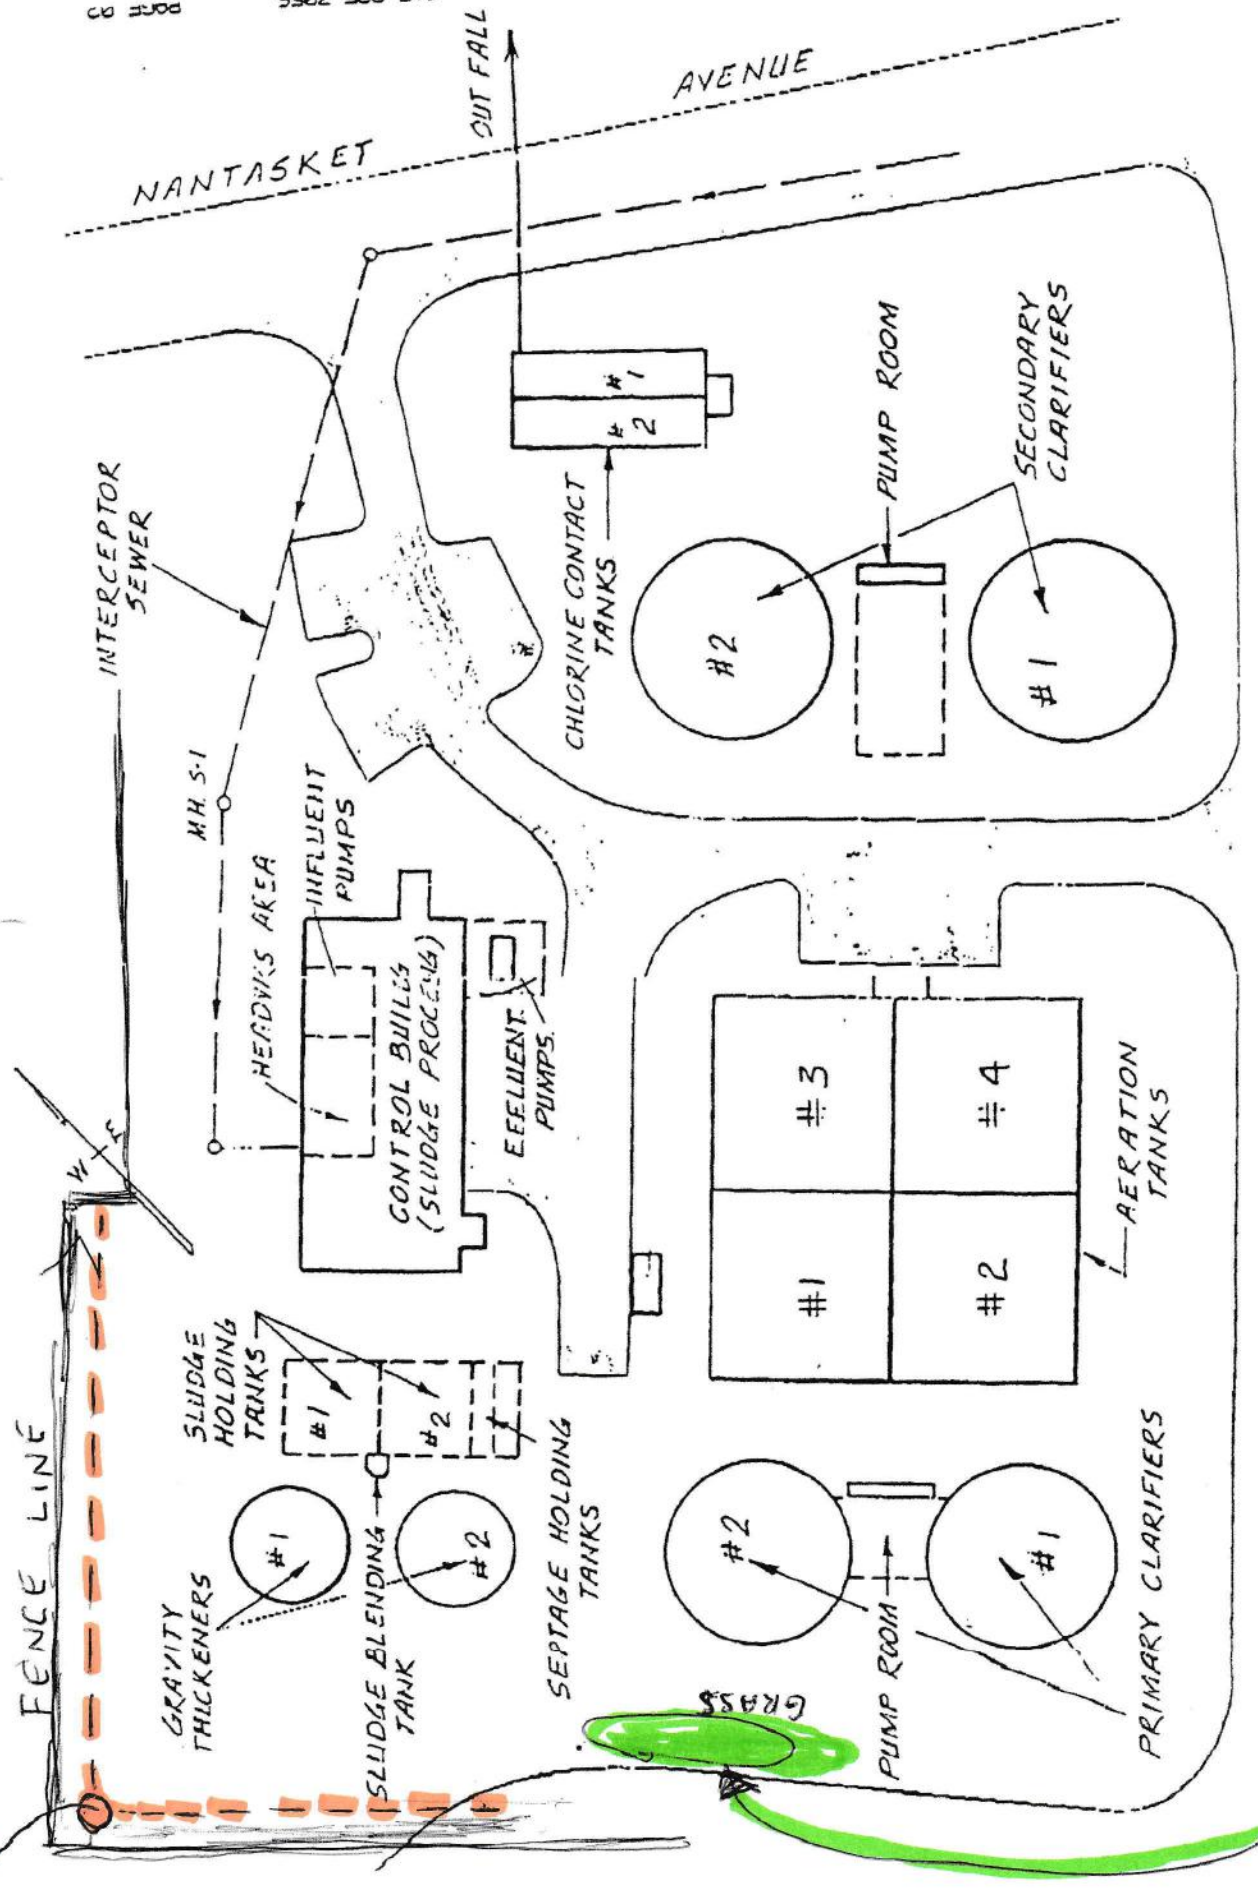
ROUTE OF DRAINAGE IF IT WERE TO OCCUR
THERE WAS NO RELEASE TO WETLAND
OR SURFACE WATER

APPROX AREA OF SSO.

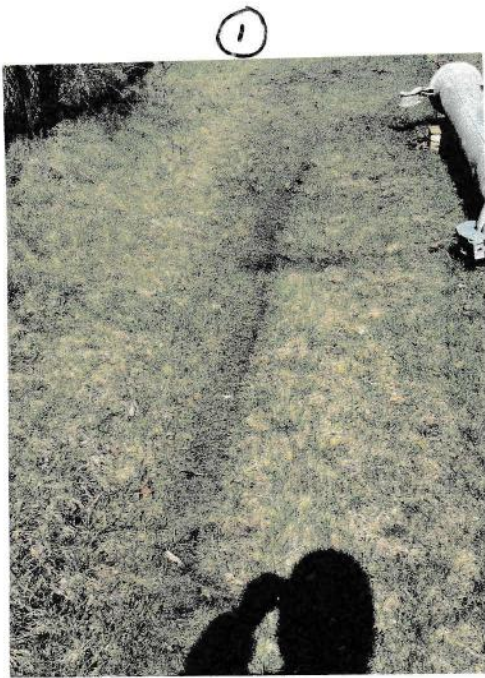
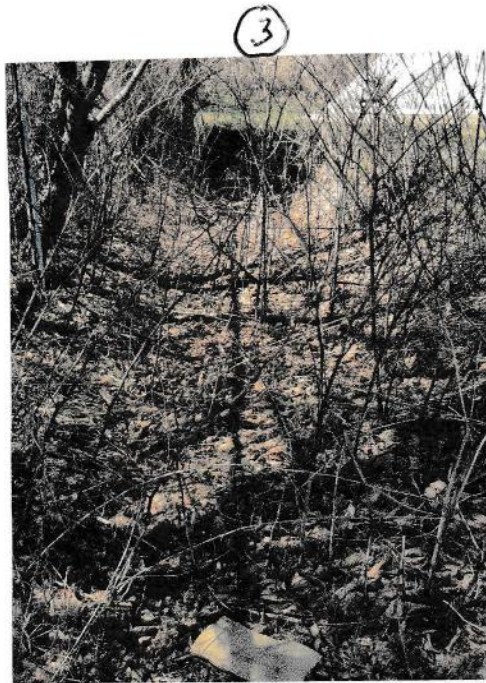
LAT / LON: Decimal Degrees **42.304844 / -70.899960** [approximate location on property]
- C. Cause of unauthorized discharge: The 12-inch pipe had not drained out sufficiently after use. Uneven terrain for the piping layout did not allow for adequate draining of the piping. Separation of temporary steel piping on the plant site in the area of the primary clarifiers & distribution box. The location where the initial separation of pipes was made, was a high spot in the run of piping, where it was assumed draining of the pipes had occurred.

PICTURES 1 + 2 - GRASSY AREA where SSO occurred,

- O. Corrective actions taken: SSO section C-7. Quicklime was applied to the affected area

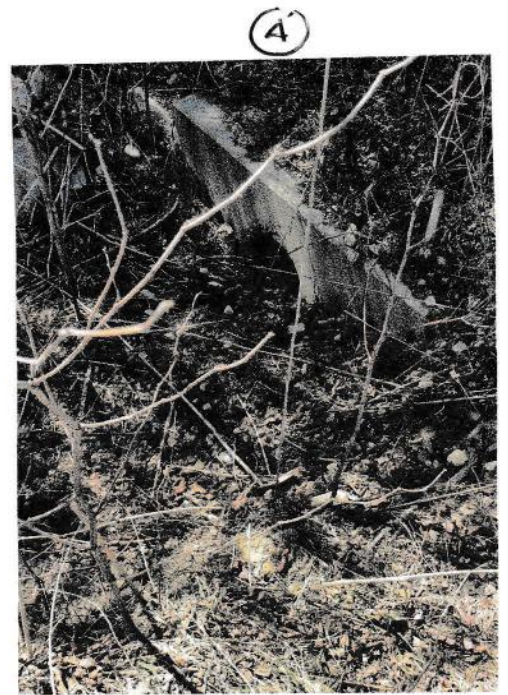
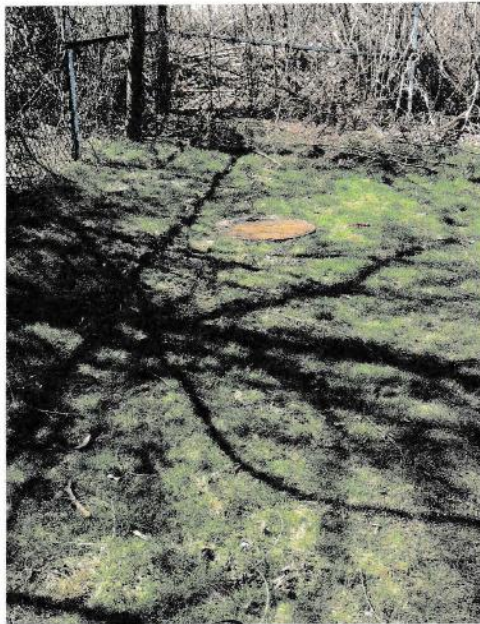
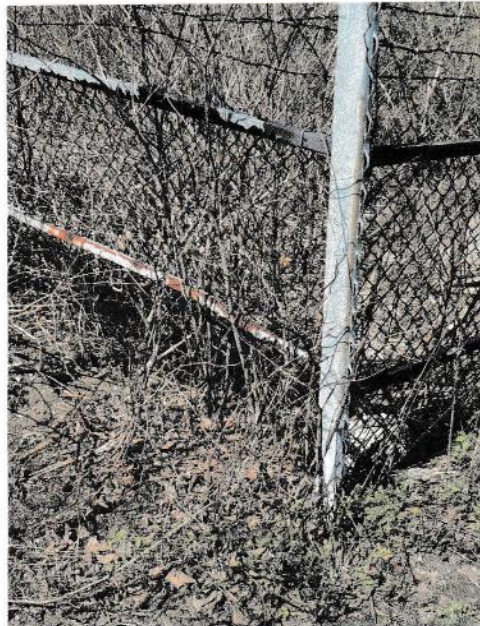
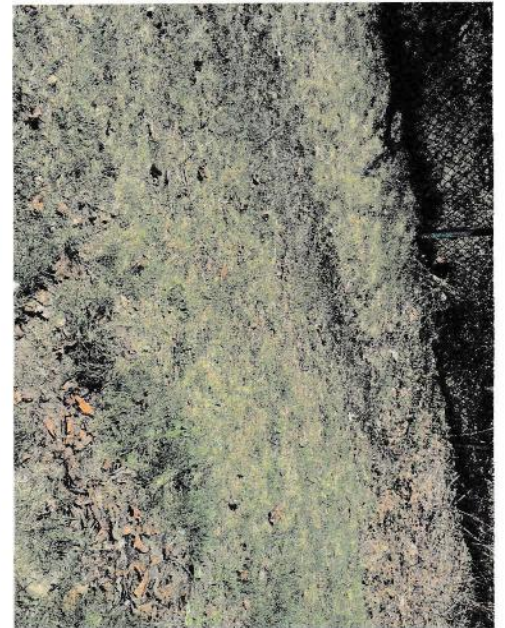
PICTURES 3 → 4 → 5 → 6 SHOW THE AREA/PATH OF
DRAINAGE FROM THIS AREA IF IT WERE TO OCCUR.

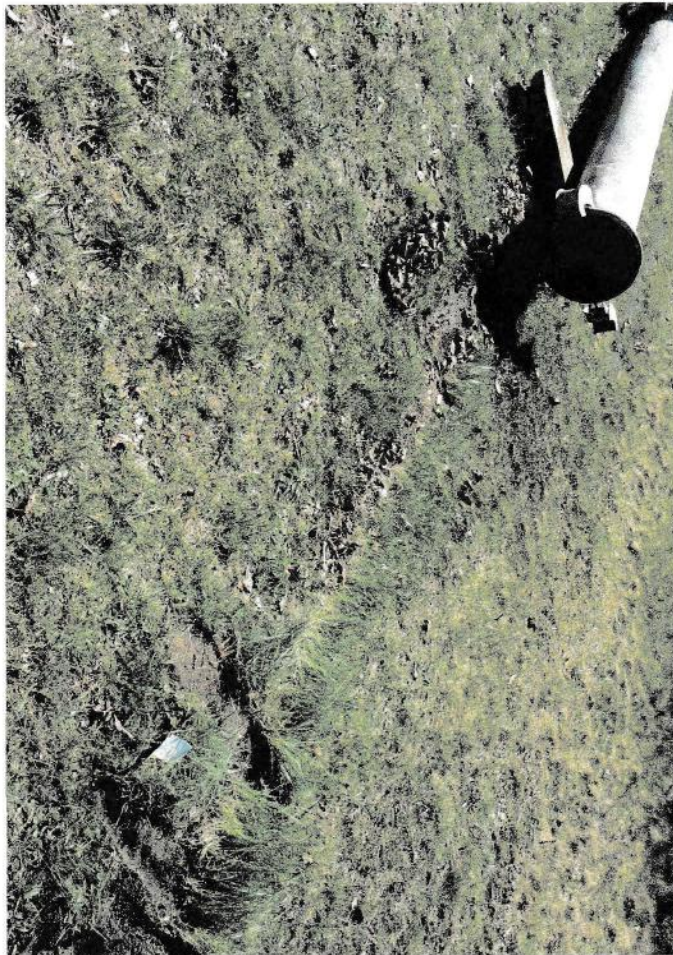
Blocked up section of
pipe to prevent
SPILLAGE

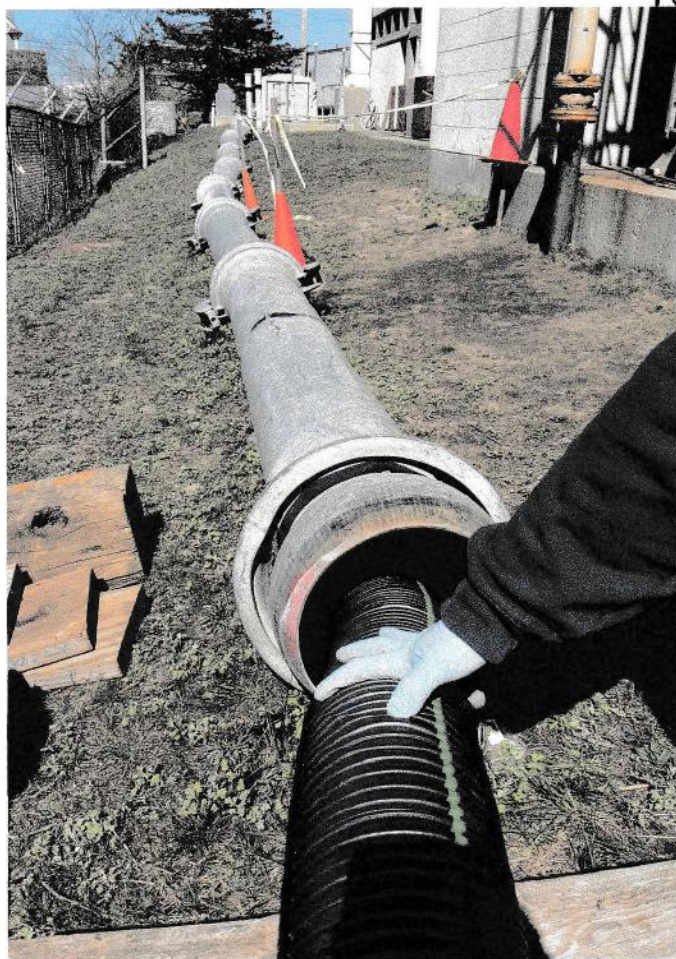
← vacuuming out
 of pipe before disassembly
